DOT HS 808 220

June 1994

# **Final Report of a 1991 Chevrolet Silverado into a 50% Left Offset Barrier in Support of CRASH3 Damage Algorithm Reformulation**

The purpose of the five (5) 50% left frontal offset barrier impact tests was for research and development in support of the CRASH3 damage algorithm reformulation.

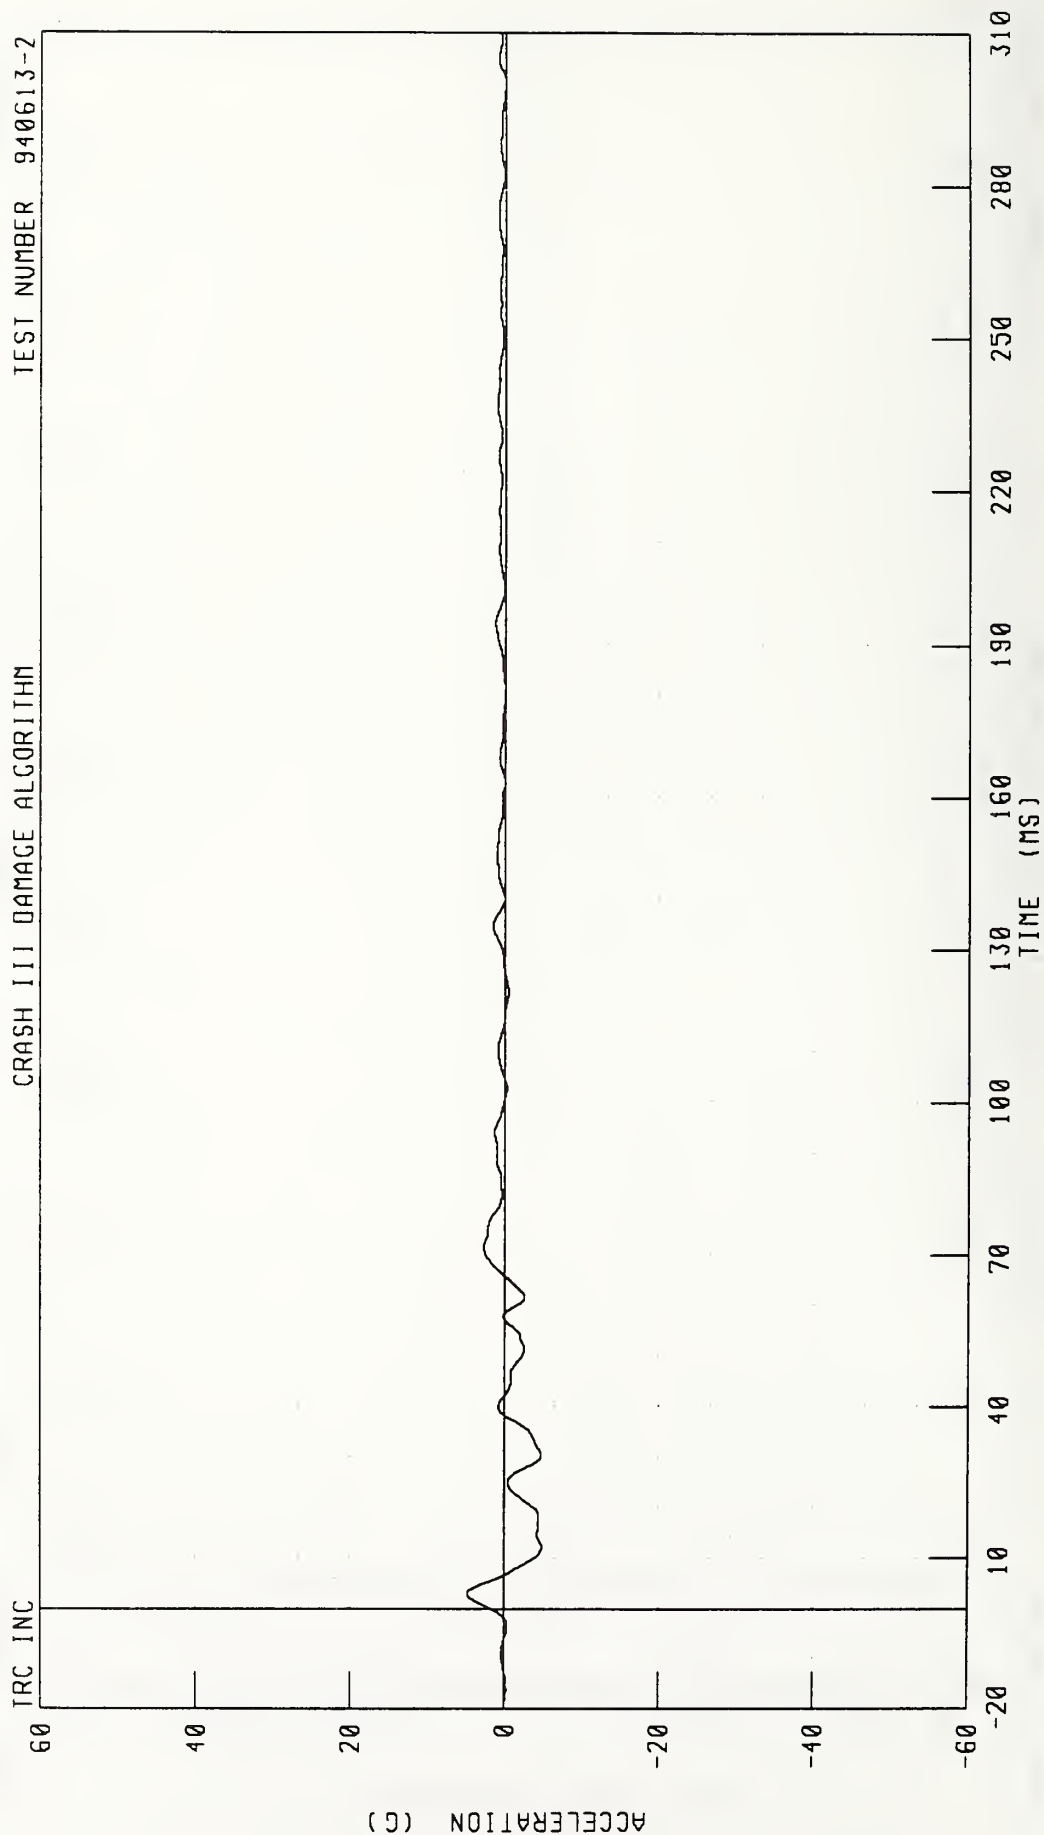
TEST NUMBER 940613-2

CHANNEL: VCGY01 FILTER: CH. CLASS 60

PEAK DATA: 4.78 G @ 2.88 MS, -4.83 G @ 12.16 MS

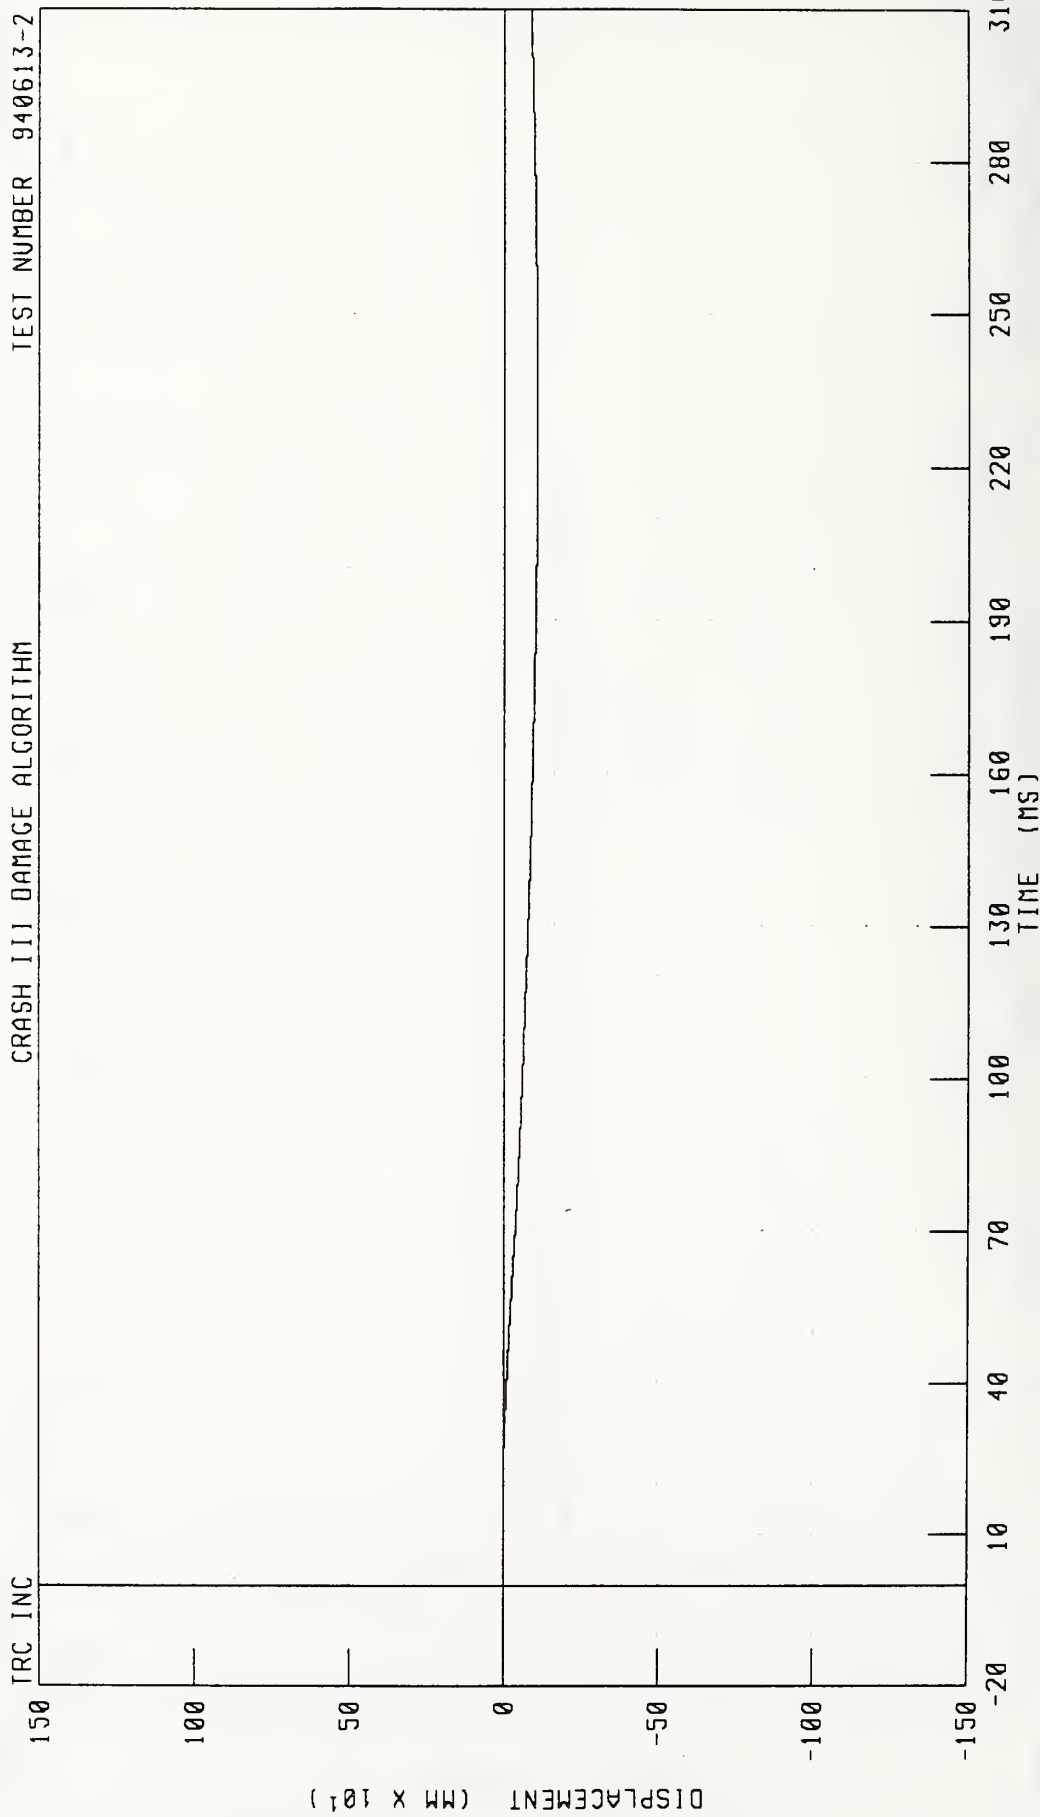
TEST NUMBER 940613-2

CHANNEL VCCYD1 FILTER CH CLASS 180

PEAK DATA: 1 68 MM @ 12 96 MS, -106 51 MM @ 231 12 MS

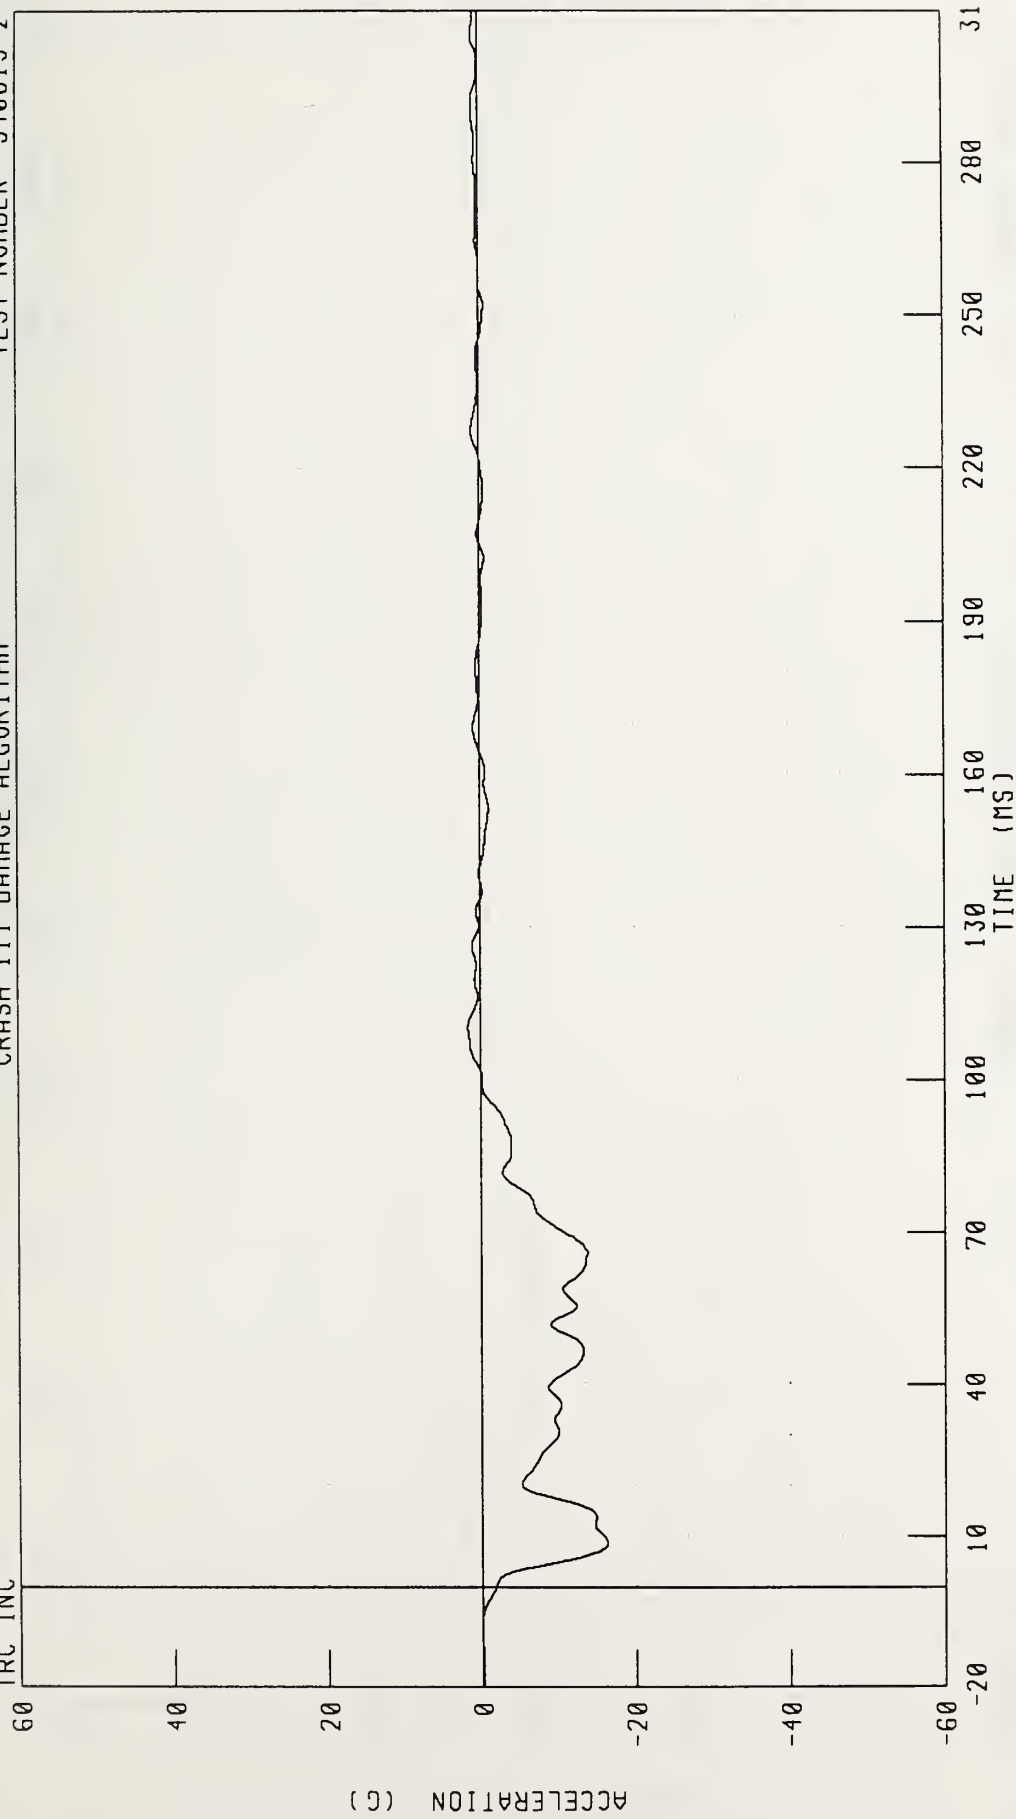
TEST NUMBER 940613-2

1991 CHEVROLET SILVERADO PICKUP TRUCK INTO 50% LEFT OFFSET BARRIER  
LEFT REAR SILL X-AXIS ACCELERATION  
CRASH III DAMAGE ALGORITHM

CHANNEL LRSXG1 FILTER CH CLASS 60

PEAK DATA 1 64 G @ 110 16 MS, -16 25 G @ 8 64 MS

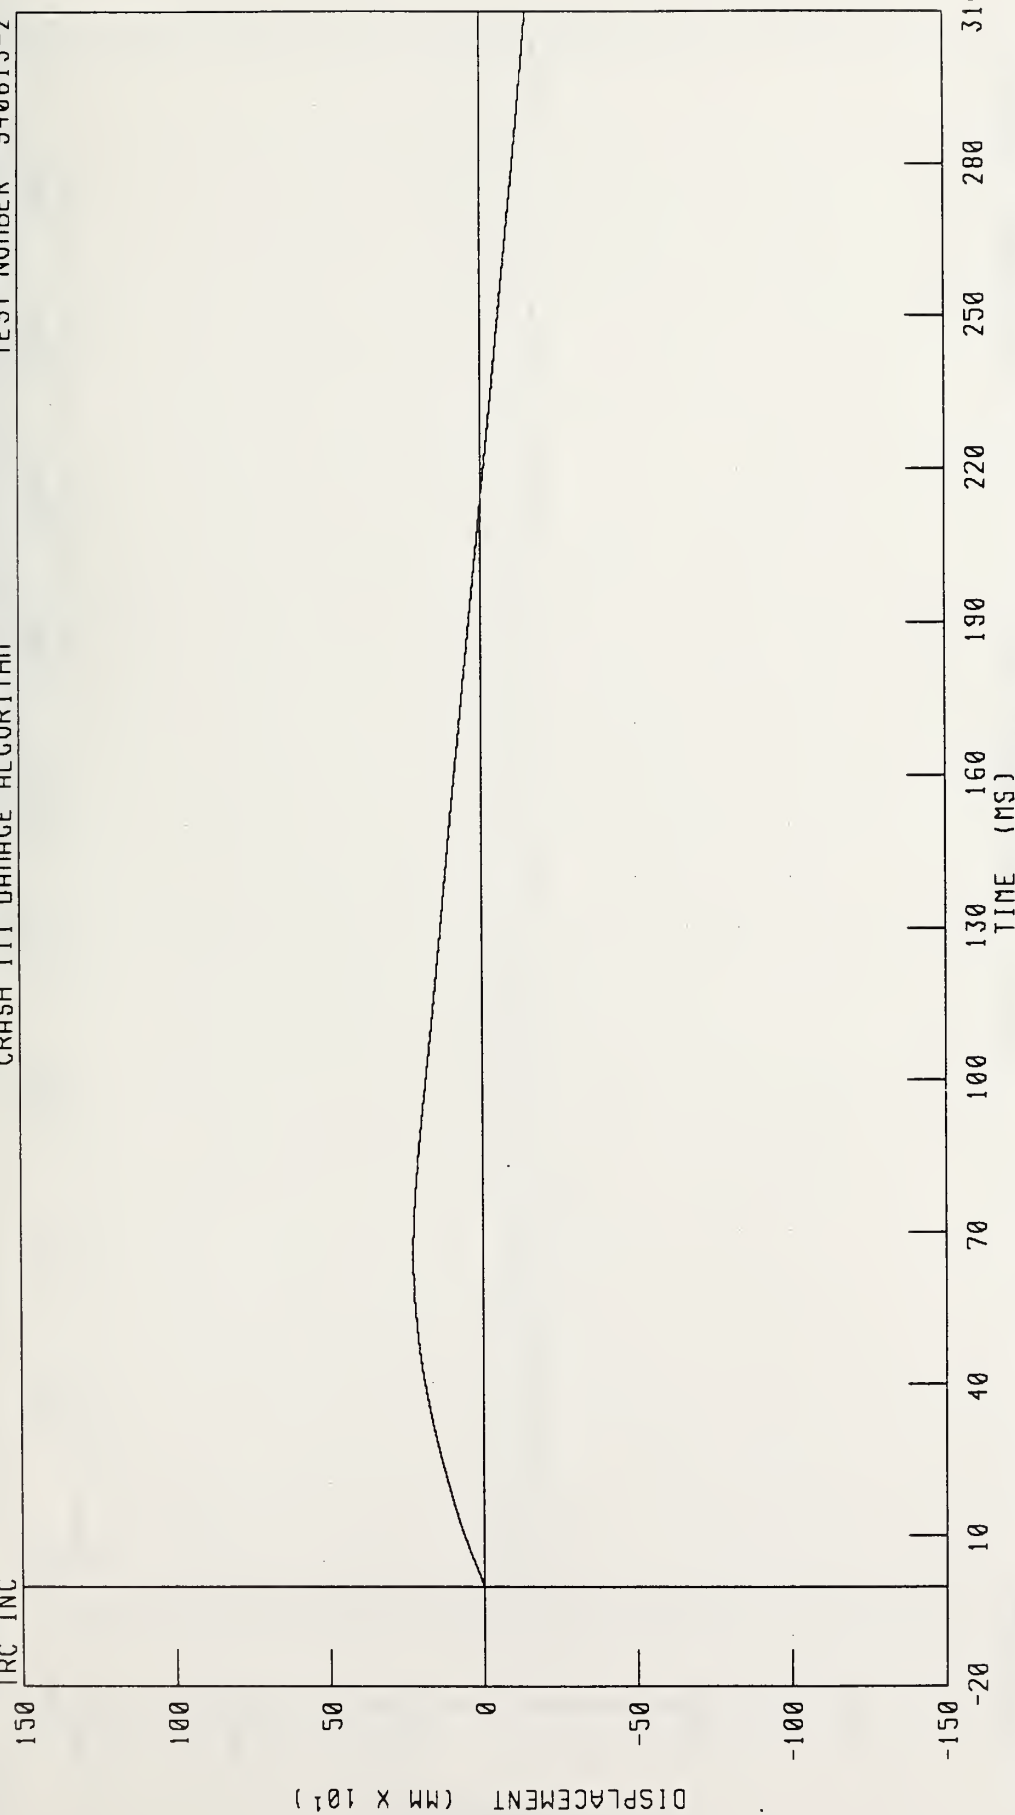
CHANNEL LRSXD1 FILTER CH CLASS 180

PEAK DATA 227 67 MM @ 65 44 MS, -149 35 MM @ 310 00 MS

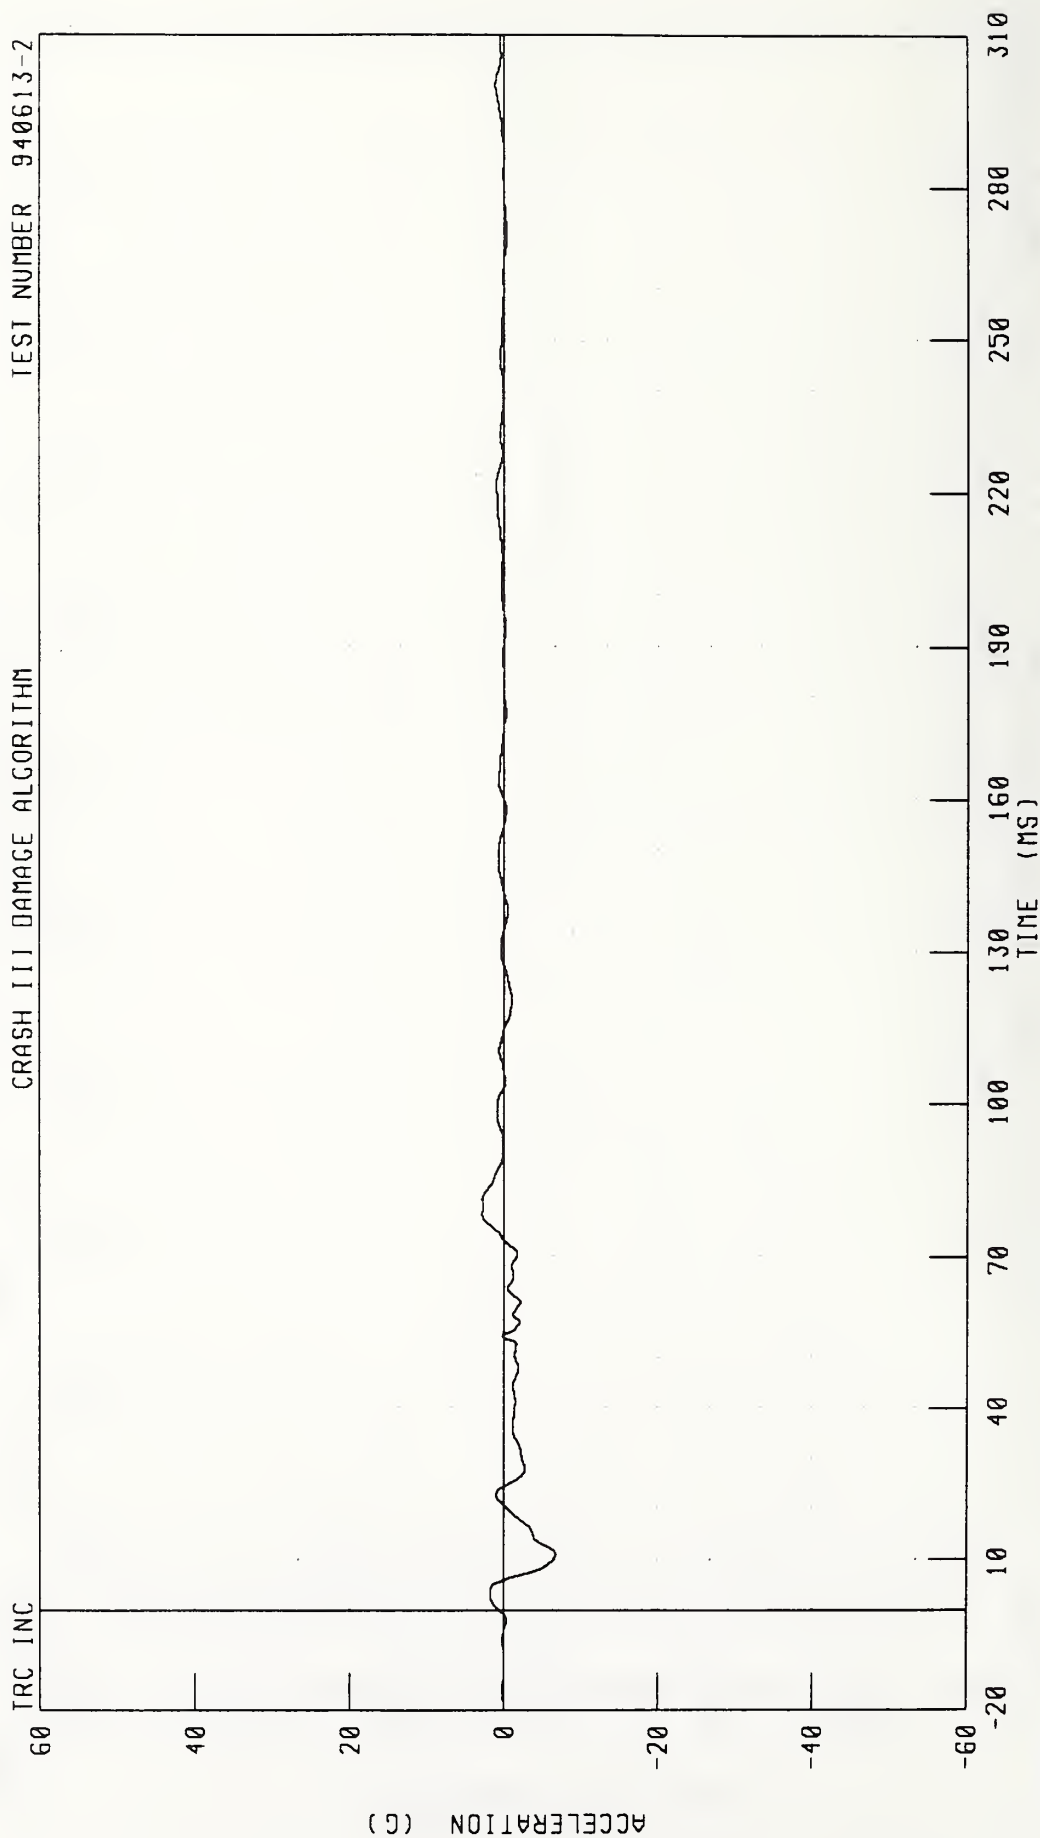
TEST NUMBER 940613-2

CHANNEL LRSYG1 FILTER CH CLASS 60

PEAK DATA 2 81 G @ 78 40 MS, -6 70 G @ 10 96 MS

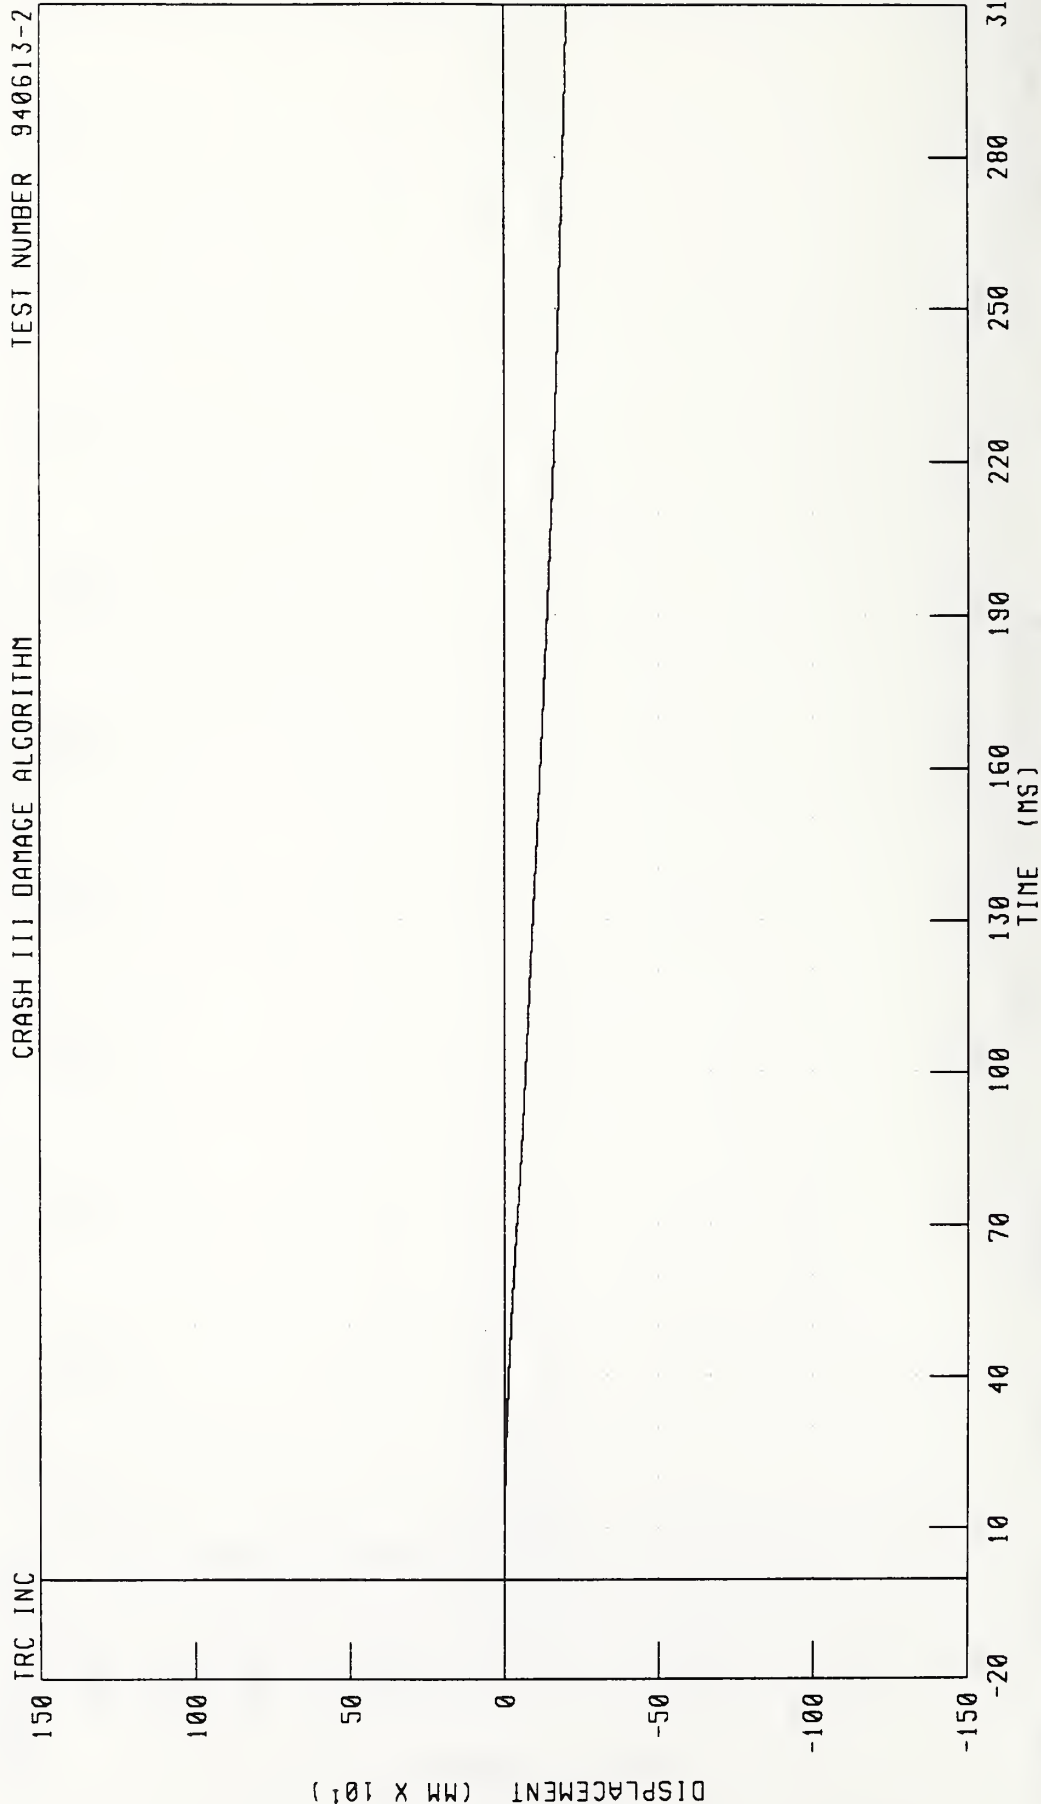
CRASH III DAMAGE ALGORITHM TEST NUMBER 940613-2

1991 CHEVROLET SILVERADO PICKUP TRUCK INTO 50% LEFT OFFSET BARRIER  
LEFT REAR SILL Y-AXIS DISPLACEMENT

CHANNEL LRSYD1 FILTER: CH. CLASS 180

PEAK DATA: 0.57 MM @ 80 MS, -203.85 MM @ 310 00 MS

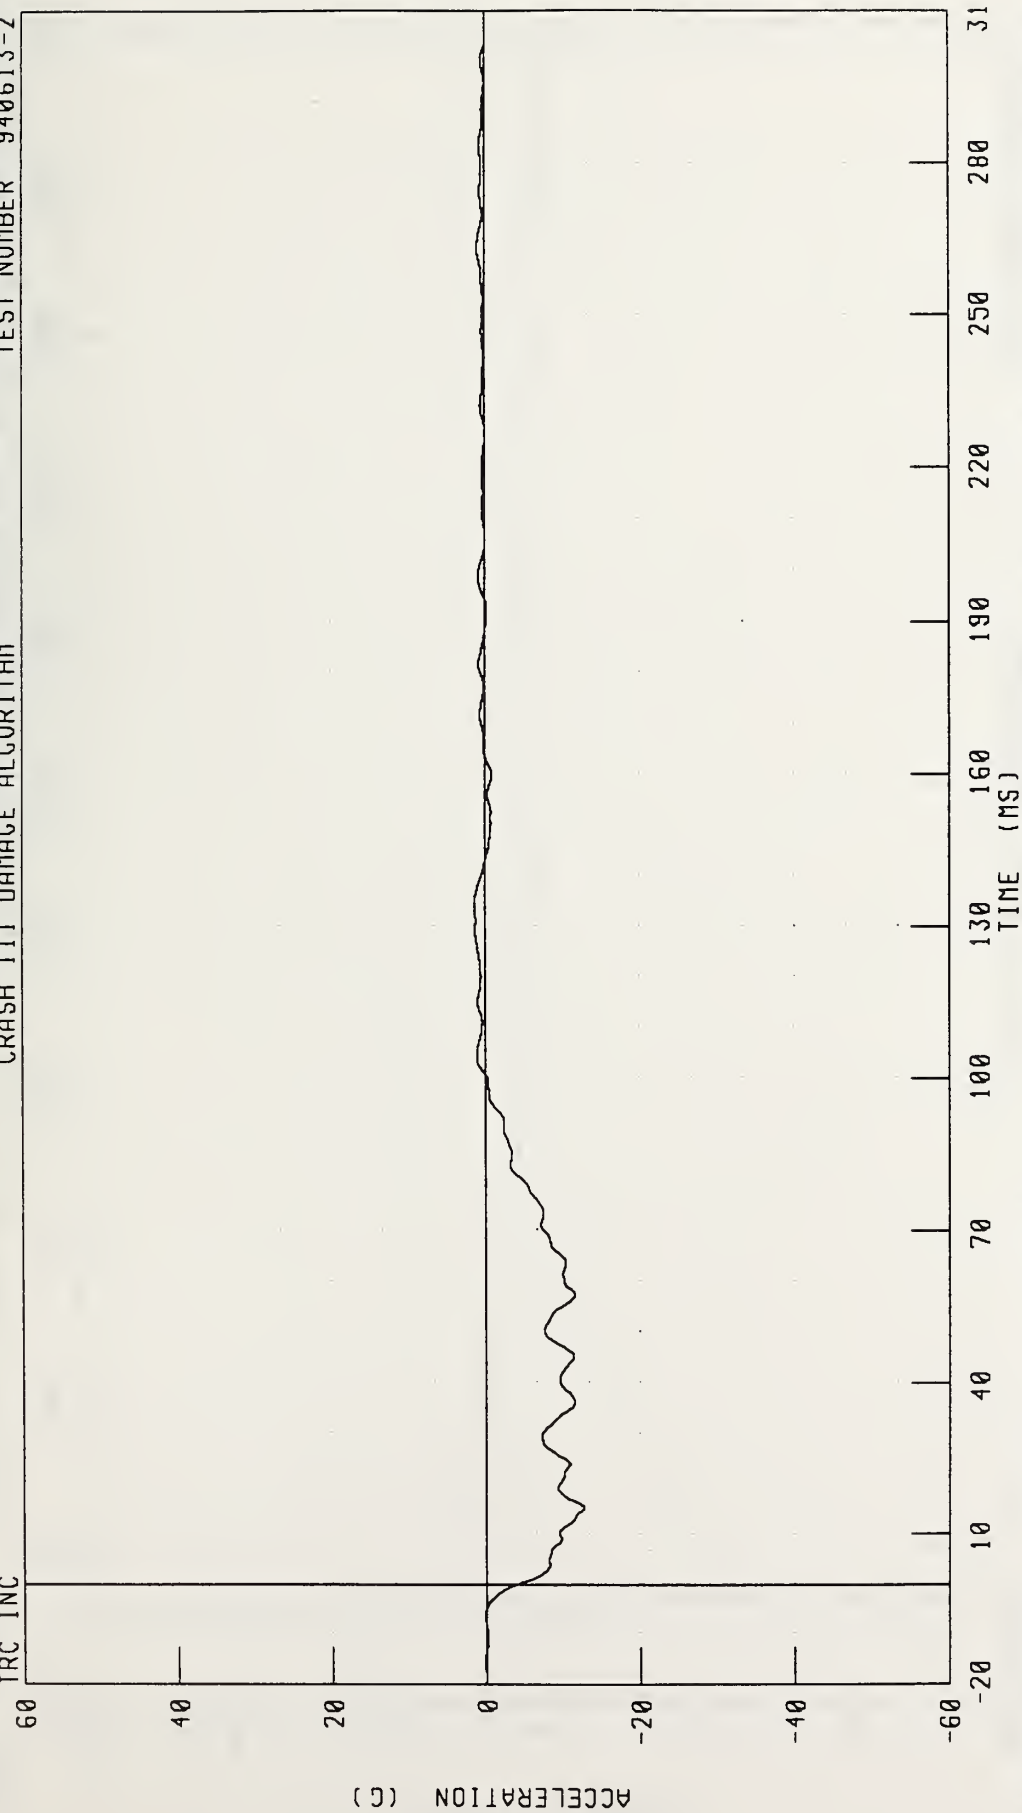
TEST NUMBER 940613-2

CHANNEL RRSXG1 FILTER CH CLASS 60

PEAK DATA 1.41 G @ 133.28 MS, -12.68 G @ 15.20 MS

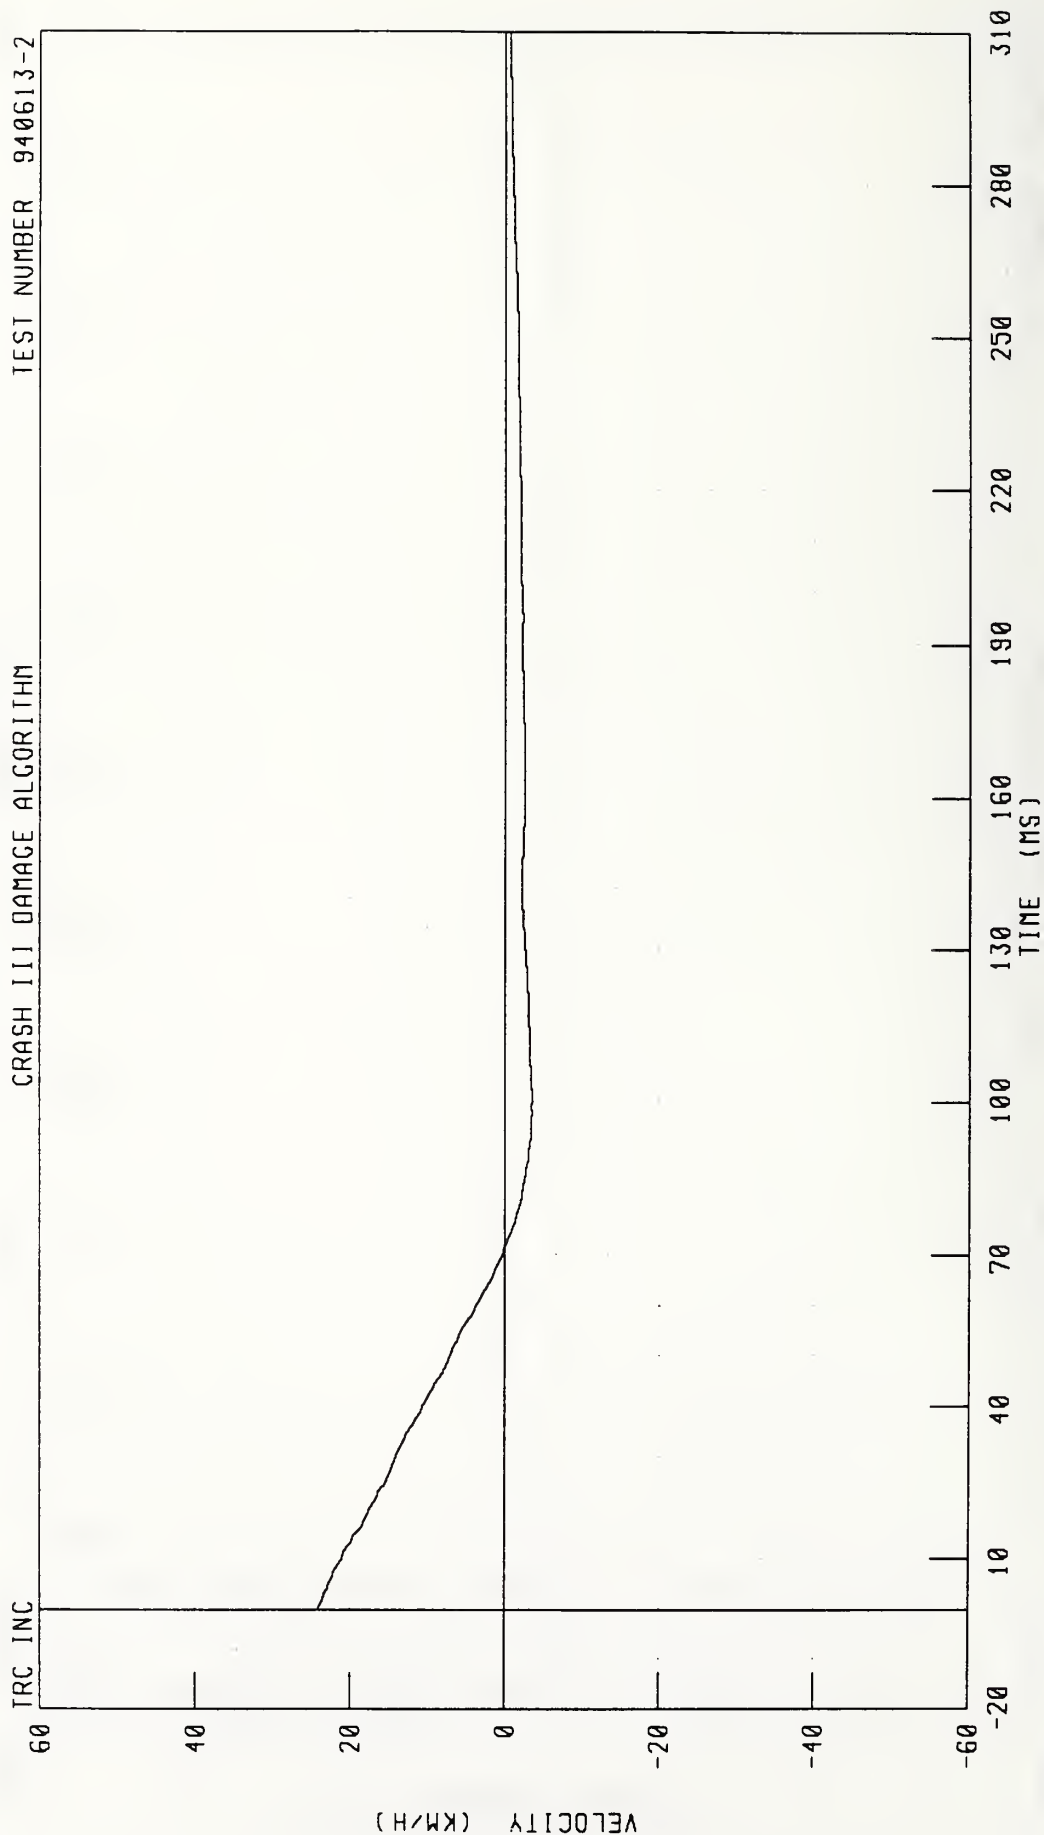
CRASH III DAMAGE ALGORITHM TEST NUMBER 940613-2

RIGHT REAR SILL X-AXIS VELOCITY

CHANNEL RRSXV1 FILTER CH CLASS 180

PEAK DATA: 24.10 KM/H @ 0.00 MS, -3.53 KM/H @ 100.88 MS

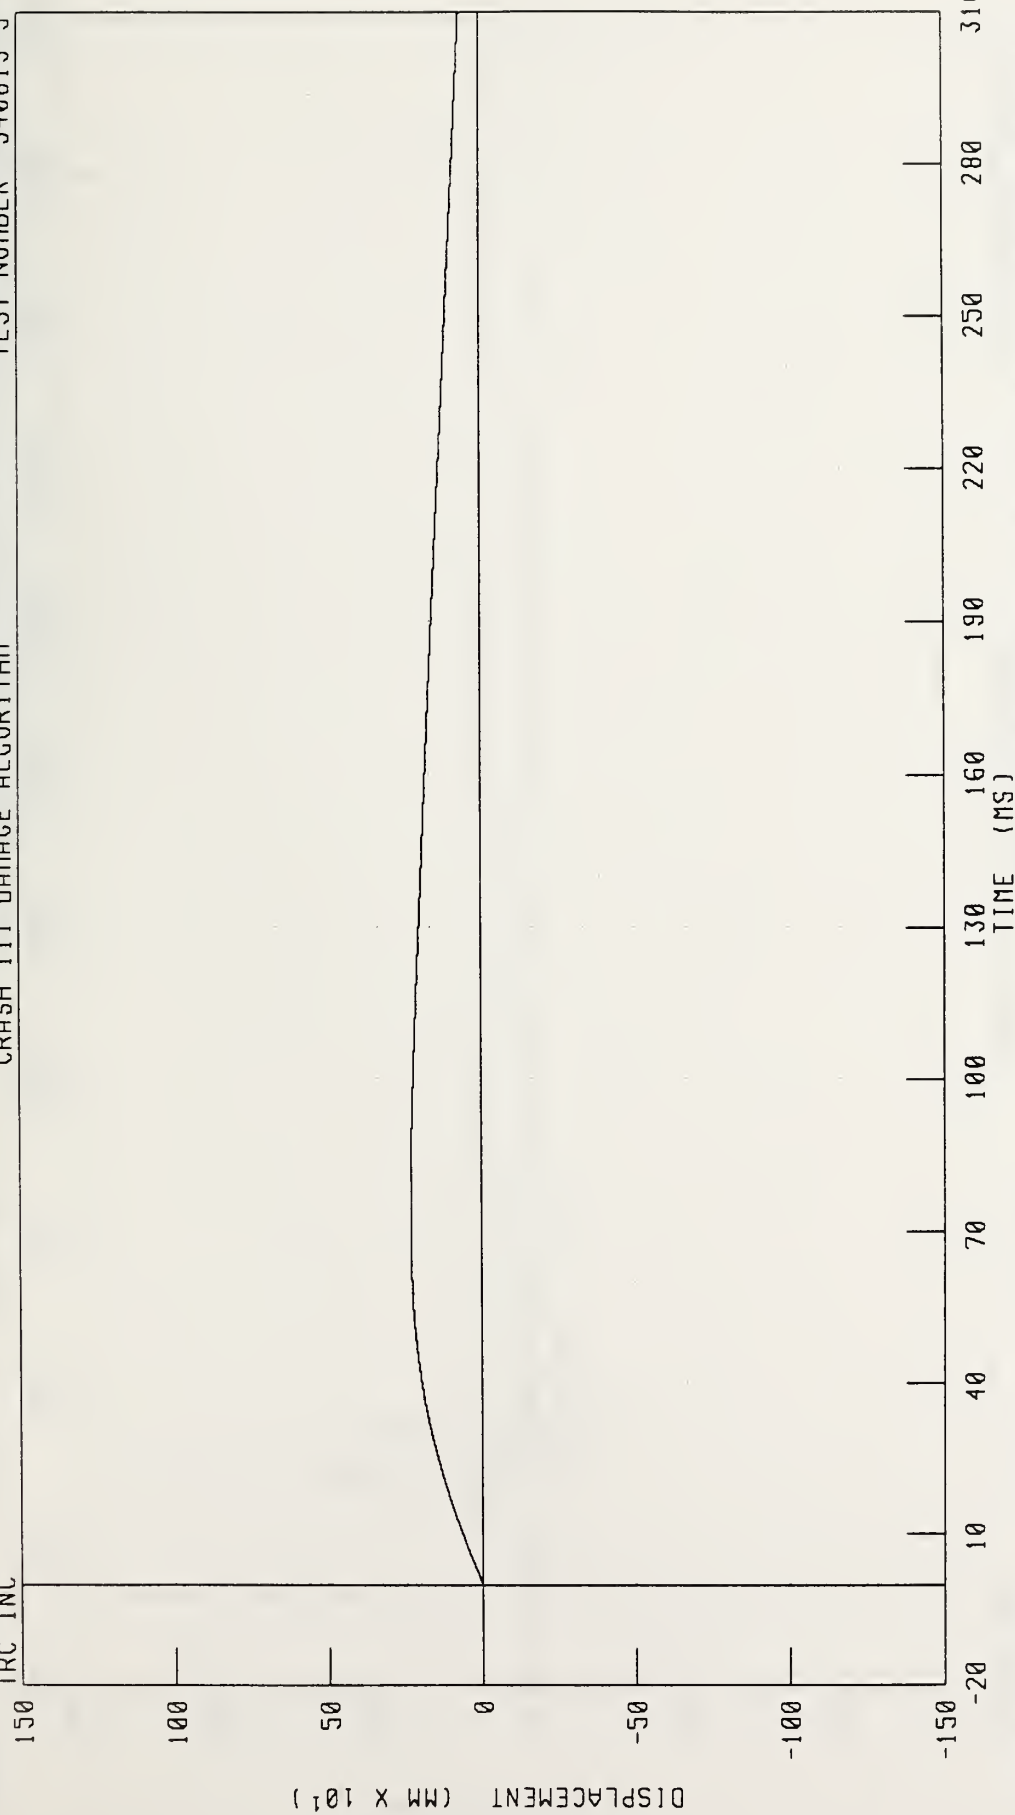
CHANNEL VCGXD1 FILTER CH CLASS 180 PEAK DATA 230 15 MM @ 74 16 MS, 0 00 MM @ 0 00 MS

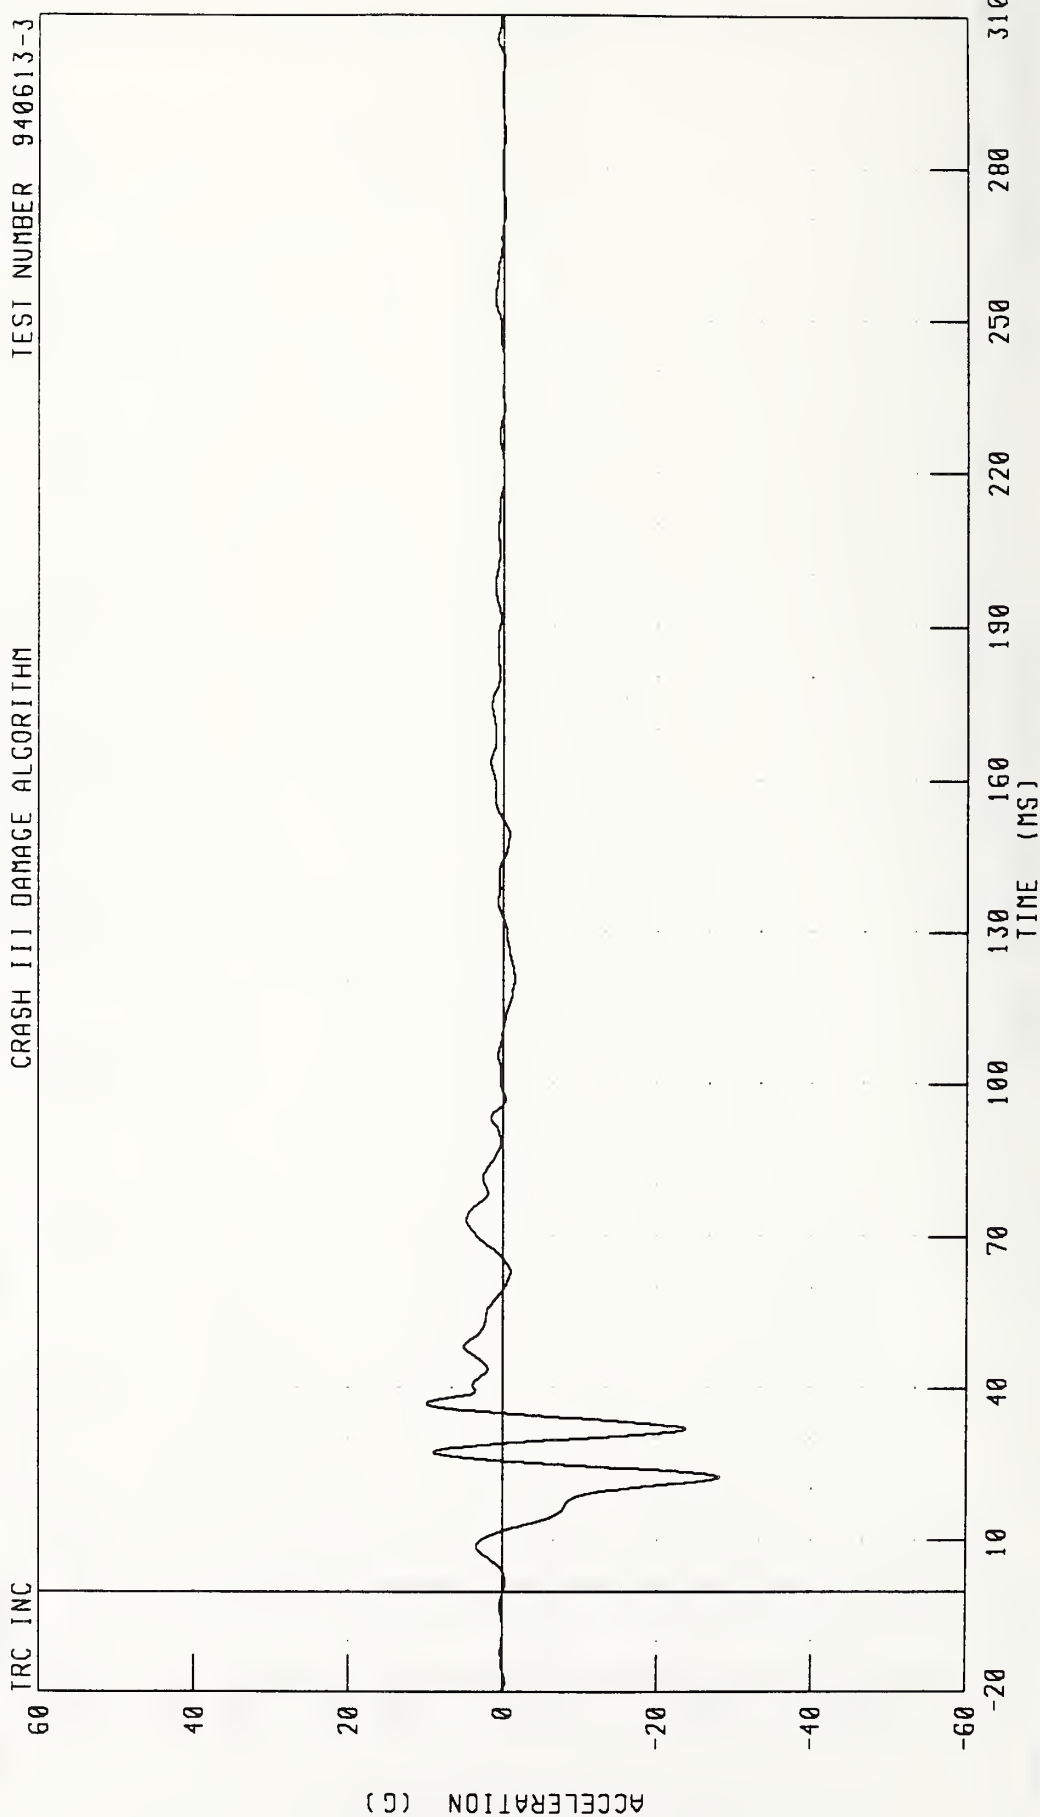
TEST NUMBER 940613-3

CHANNEL: VCGY61 FILTER: CH CLASS 60

PEAK DATA: 9 91 G @ 37 04 MS, -28 07 G @ 22 48 MS

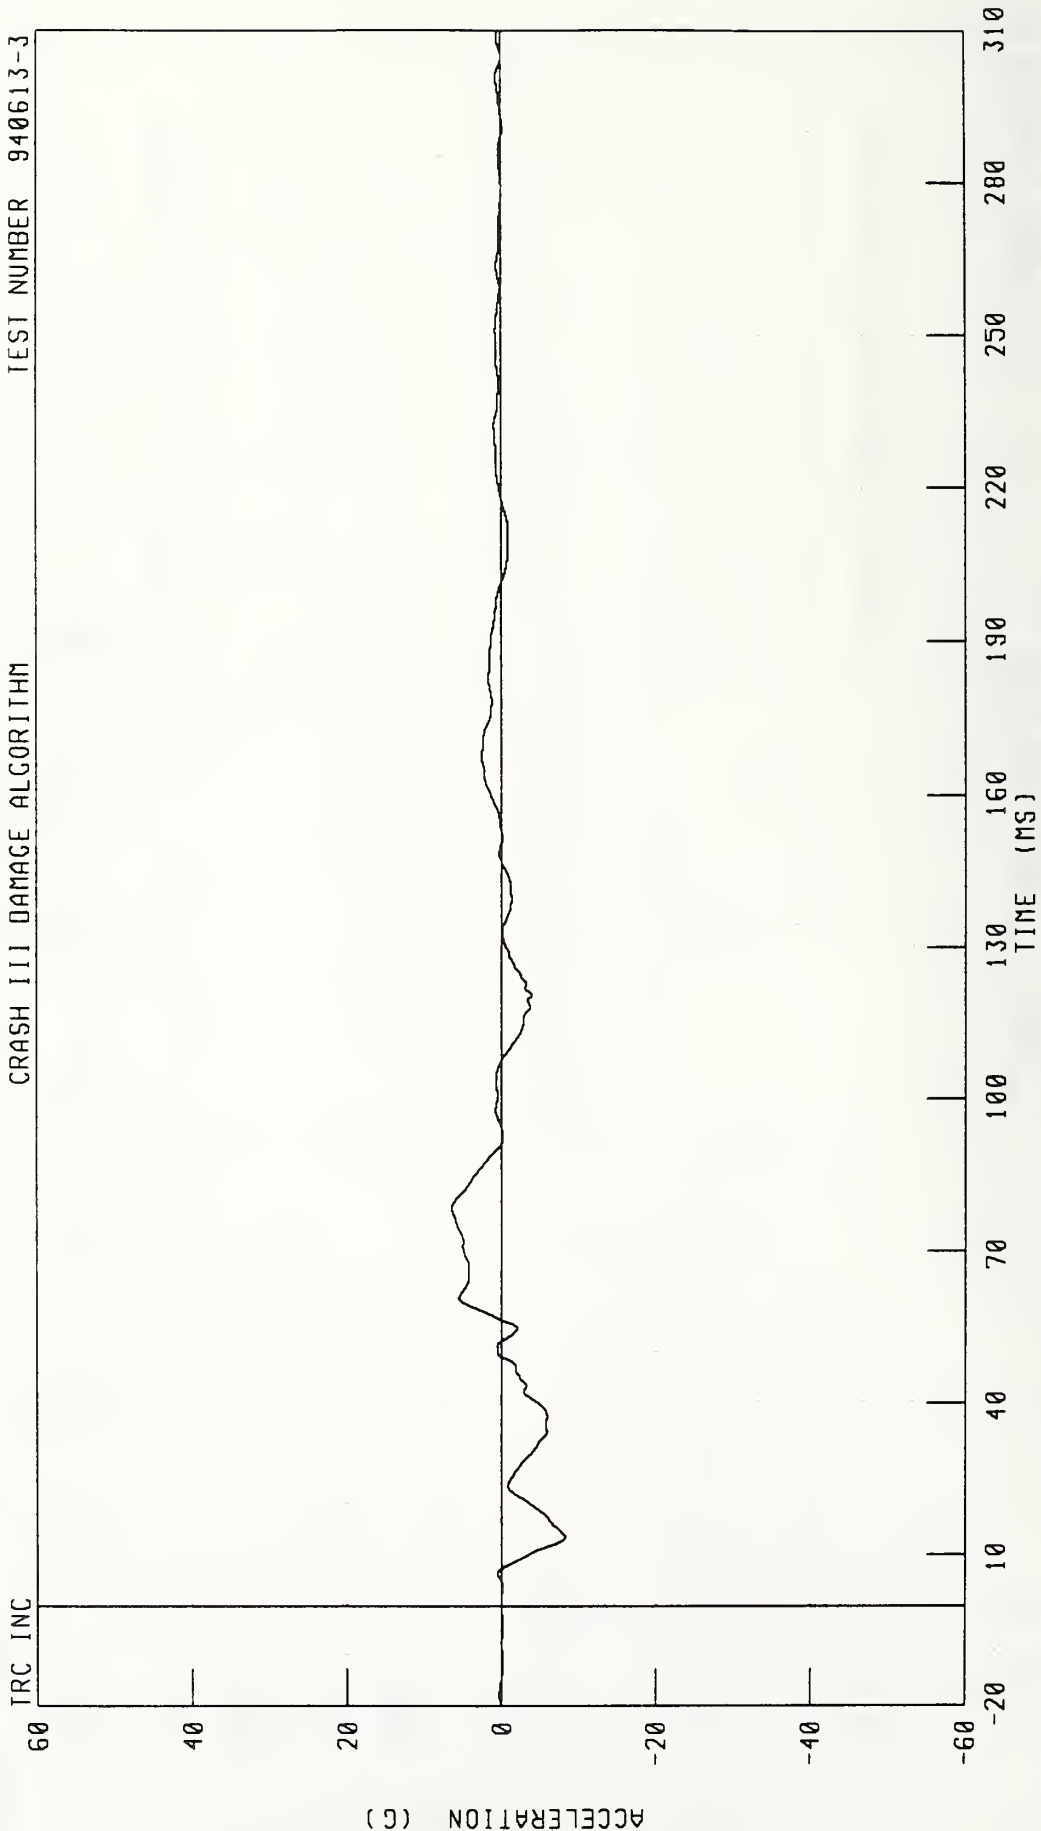
CRASH III DAMAGE ALGORITHM TEST NUMBER 940613-3

LEFT REAR SILL Y-AXIS ACCELERATION

CHANNEL: LRSYG1 FILTER: CH CLASS 60

PEAK DATA: 6.39 G @ 78.56 MS; -8.27 G @ 13.60 MS

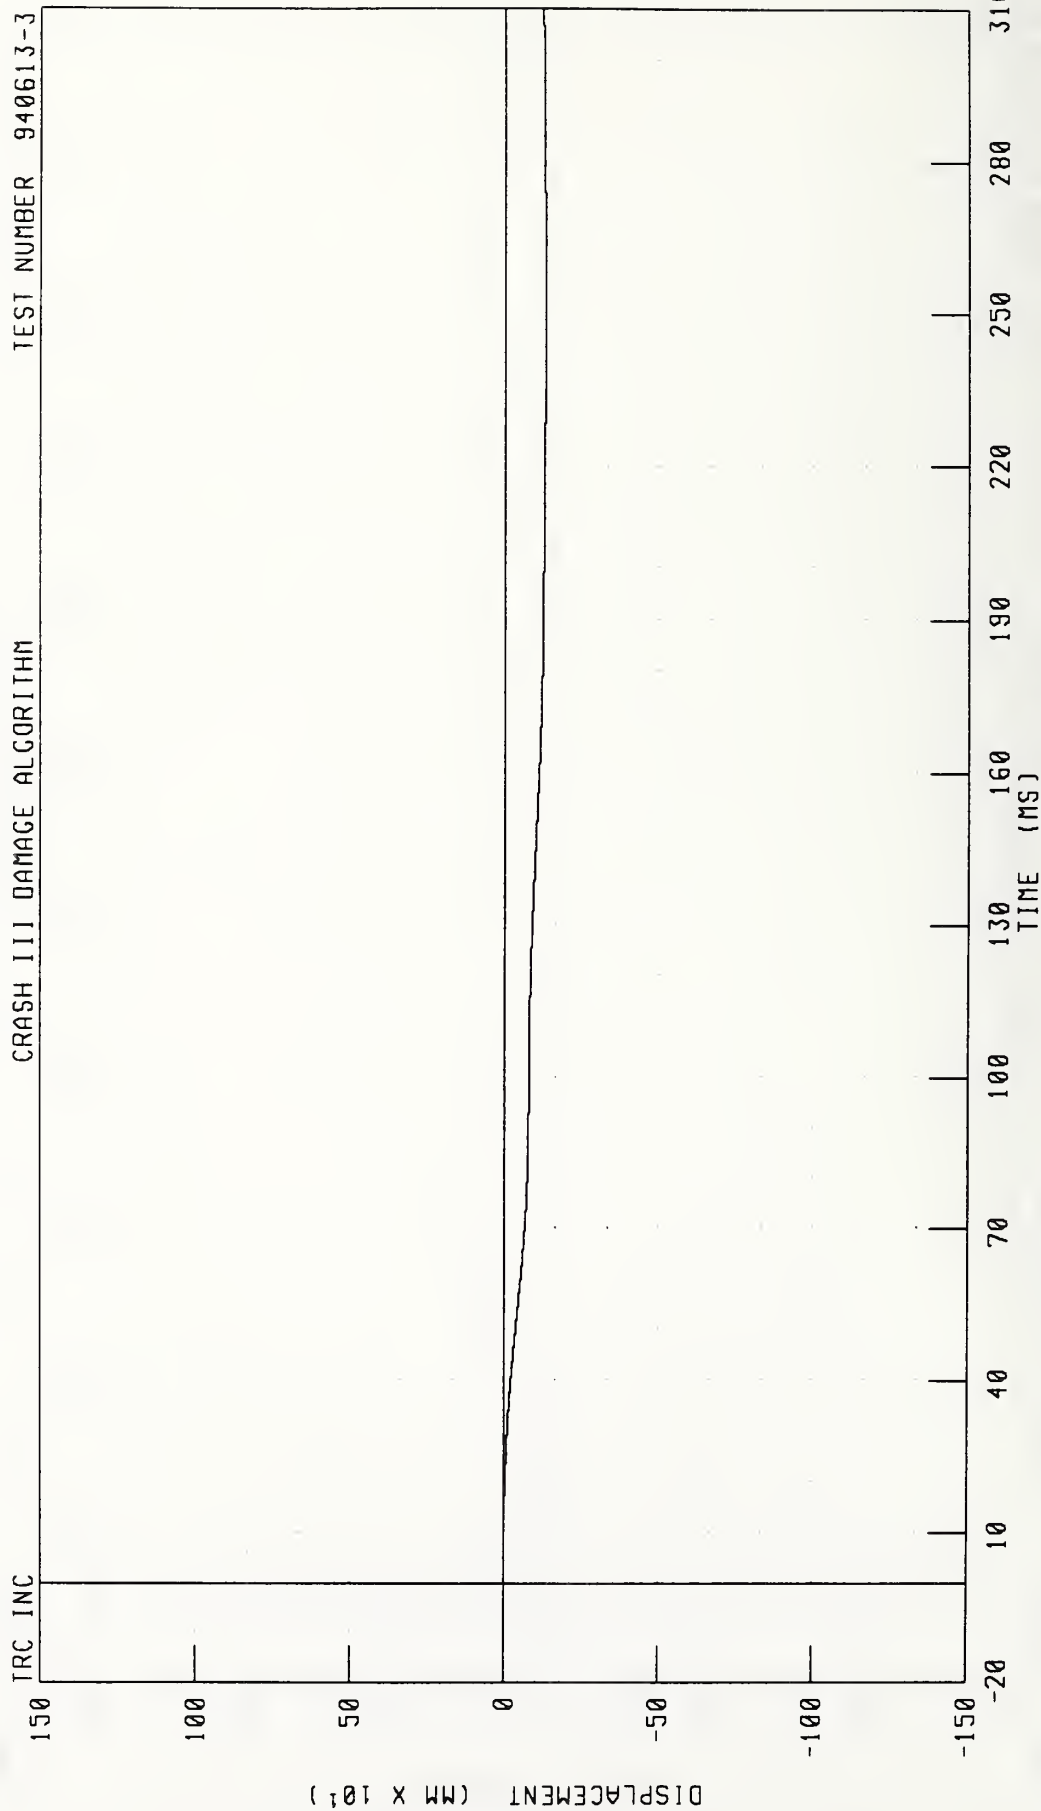
CRASH III DAMAGE ALGORITHM TEST NUMBER 940613-3

1991 CHEVROLET SILVERADO PICKUP TRUCK INTO 50% LEFT OFFSET BARRIER  
LEFT REAR SILL Y-AXIS DISPLACEMENT

CHANNEL LRSYD1 FILTER: CH. CLASS 180

PEAK DATA: 0 03 MM @ 9 04 MS, -130 30 MM @ 250 32 MS
